**SOME CREEP CHARACTERISTICS OF  
BERYLLIUM-COPPER AT 300°C**

This work is accepted as fulfilling  
the thesis requirements for the degree of

MASTER OF SCIENCE  
IN  
MECHANICAL ENGINEERING

from the  
United States Naval Postgraduate School

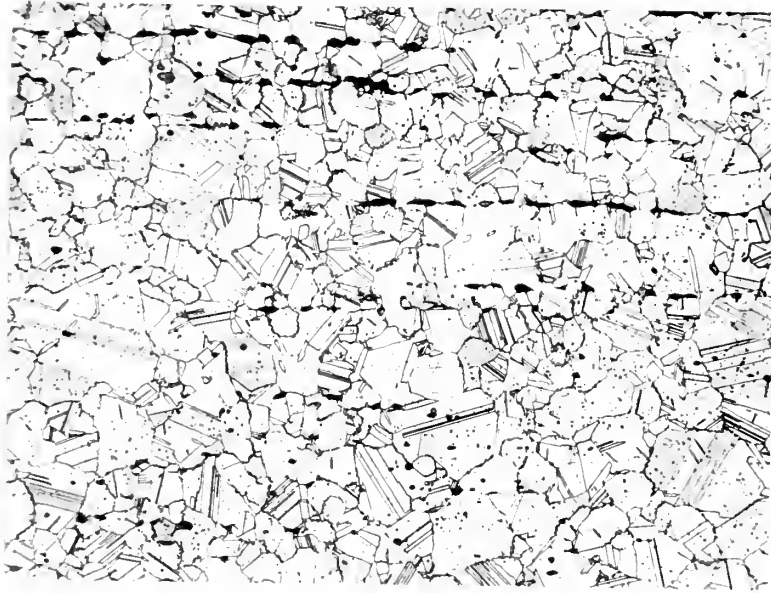
FIGURE 1--A Condition

The appearance of the microstructures of these states before testing are shown in Figures 1 - 5, respectively. These micrographs show the presence of beta stringers which are due to incomplete homogenization. These beta stringers may have several undesirable characteristics; one of these is that the amount of beryllium in the alpha phase is reduced and is therefore not "available" for hardening. In addition, the "as-received" material (see Figures 1 and 3) showed a condition variously described as "grain boundary precipitate" or "grain boundary gamma". The cause or composition of this boundary phase is not fully understood and is the subject of considerable controversy<sup>(6)</sup>. However, this formation results, at least in part, from commercial mill practice. Its effect is to form clumps or masses of a phase along the grain boundaries that may have many undesirable consequences, among them excess distortion of the piece when heat treated. A slight amount of visible general precipitate within the grains and beryllites (beryllium-cobalt intermetallic compounds) were observed in the unaged material.

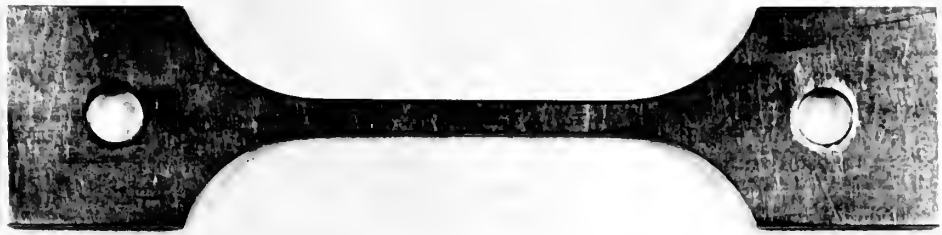
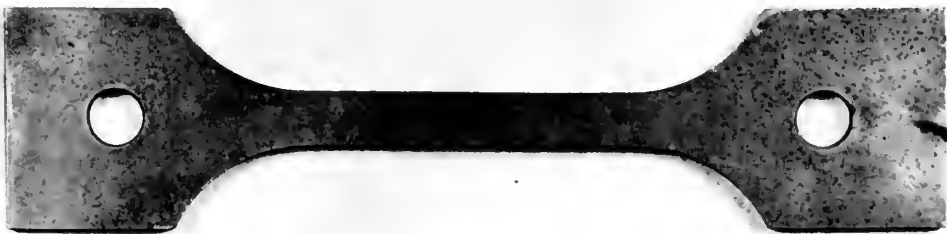
Figure 8 - Test Specimens

- (a) Final Design
- (b) Intermediate Design
- (c) Initial Design

At the beginning of this investigation it was assumed that the customary creep specimen design (see Figure 8c), being employed in the Creep Testing Laboratory of the U. S. Naval Postgraduate School, would be adequate. Upon completion of the first test on a specimen, in the HT-316 condition, based on this design it appeared that this assumption was justified as the fracture occurred within the gage section. However, the next four fractures occurred at the grip section as shown in Figure 9c). These tests were conducted on specimens in the H and HT-316 conditions.

This, obviously, meant that a design change was in order. A 60% increase in the width of the grip section was considered sufficient; this modification constituted the intermediate design as shown in Figure 8b. Four tests were then conducted using specimens of such design, in the A, H and HT-316 conditions. All of these tests resulted in fractures in the same location (see Figure 9b) as in the previous four tests.

Design	Grip Width, in.	Reduced Section Width, in.
Initial	5/8	1/4
Intermediate	1.0	1/4
Final	1.0	5/32

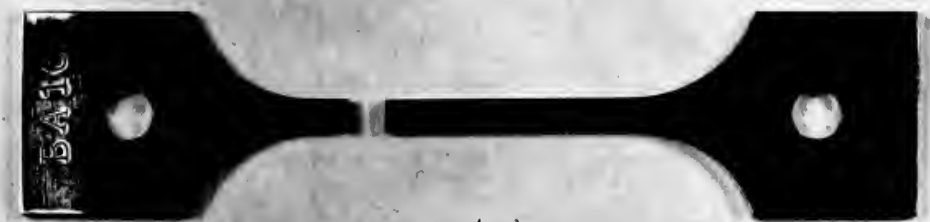
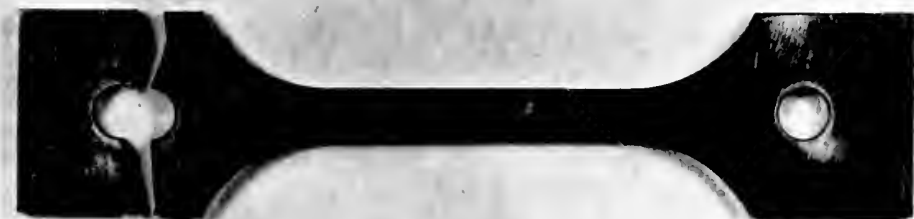
Figure 9 - Test Specimens Showing Location of Fractures Under Creep Tests at 3000C.

- (a) Final Design, AT-316 Condition
- (b) Intermediate Design, HT-316 Condition
- (c) Initial Design, AT-316 Condition

While this final change did cause the location of the fractures to shift to the reduced section (see Figure 9a), it did not solve the problem entirely. A summary of the location of fractures utilizing this design is shown in Table IV.

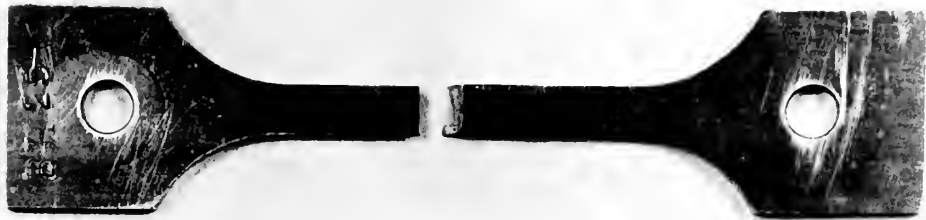
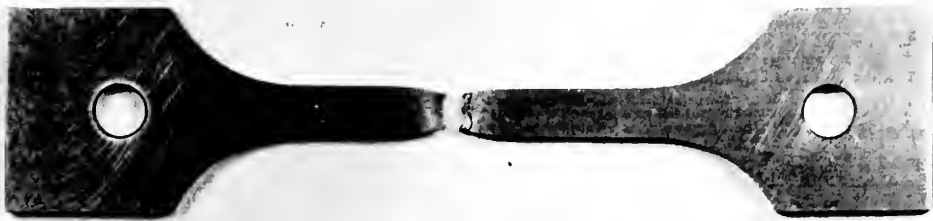
Figure 10 - Test Specimens Showing Location of Fractures  
Under Short-Time Tensile Tests at Room Temperature

- (a) Intermediate Design, HT-316 Condition
- (b) Intermediate Design, H Condition
- (c) Initial Design, H Condition

At this stage of the investigation, the writer's thoughts were, "Would these designs prove adequate when subjected to short-time tensile tests at room temperature?". The results of such tests are shown in Figure 10. Of course, the next logical
